TOOWOOMBA HOUSE INSPECTIONS & REPORTS

PRE-PURCHASE STANDARD PROPERTY REPORT

Report number: 2004202

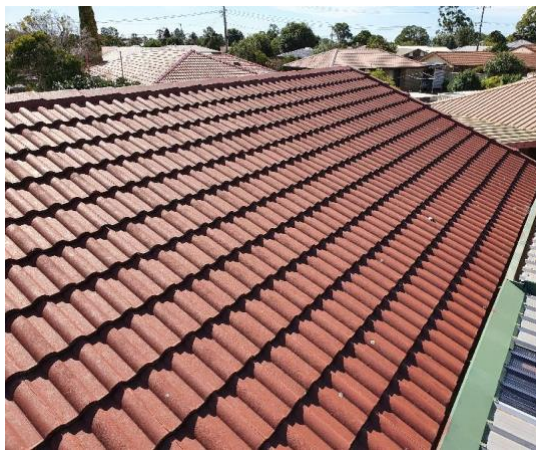
ROOF SHEETING-

The roof sheeting and gutters appears to be in a **SOUND** condition.

There are some minor defects that is typical and normal for the age of the building.

Ensure that the gutters are kept free of leaves and dirt.

Periodically inspect the roof sheeting for any possible water leaks that may develop over a period of time.

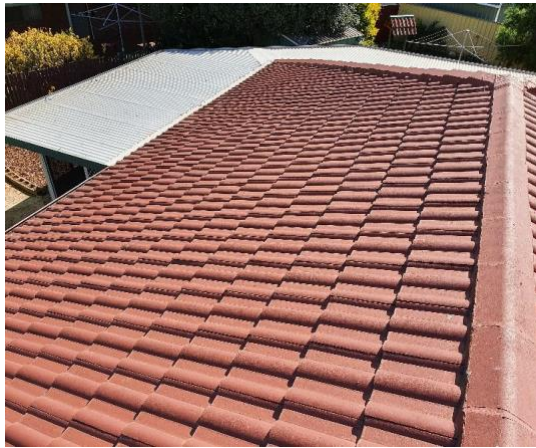
ROOF SHEETING-

The roof sheeting and gutters appears to be in a **SOUND** condition.

There are some minor defects that is typical and normal for the age of the building.

Ensure that the gutters are kept free of leaves and dirt.

Periodically inspect the roof sheeting for any possible water leaks that may develop over a period of time.

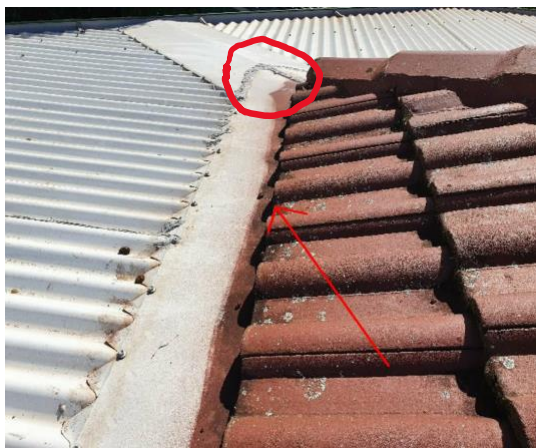
The metal apron flashing to the pergola area where it meets the roof tiles, has been carried out to a tradesman like standard and is in a good condition.

There are a number of areas that have had silicone applied to the joints laps. This silicone will eventually perish and need to be reapplied.

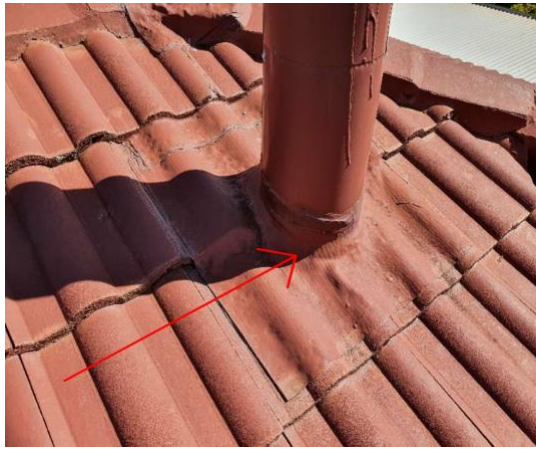
The lead flashing to the fireplace flue in good condition. There was no splitting to the lead flashing.

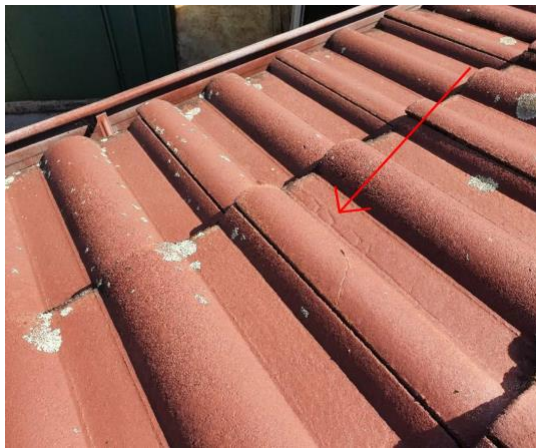
There is a hairline crack to a roof tile on the left-hand side of the building. It would be recommended to have this tile replaced or initially apply Silicon to this crack.

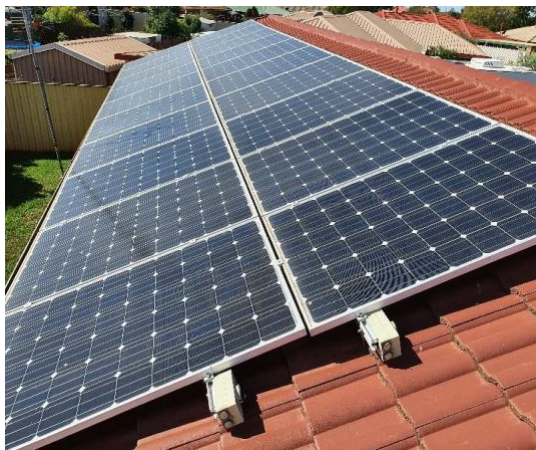
SOLAR PANEL-
The Solar panels appear to be visually in a good condition. It would be recommended to have a service agent inspect and test to confirm that the unit is working correctly and if there are any issues that could not be visually detected at the time of the inspection. It is suggested to have the solar panel washed regularly to maintain full efficiency.

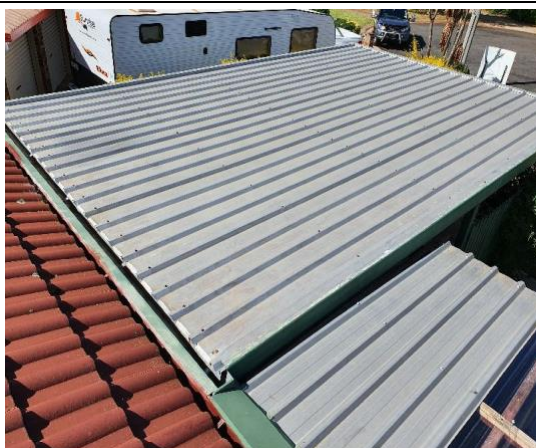
The carport roof is in a good condition and is structurally sound.

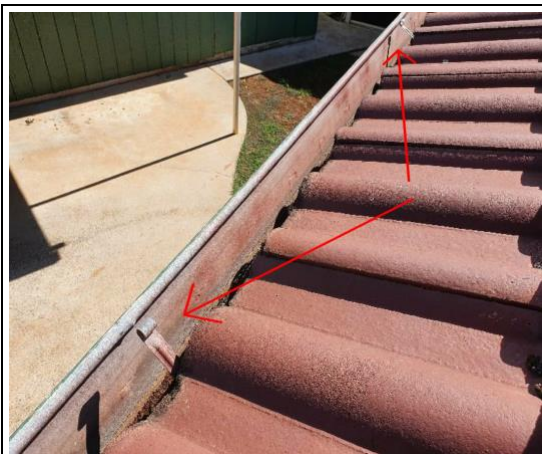
Several of the gutter brackets have popped out of the gutter. These brackets will need to be adjusted. Seek further advice from a roof plumbing contractor or Handyman.

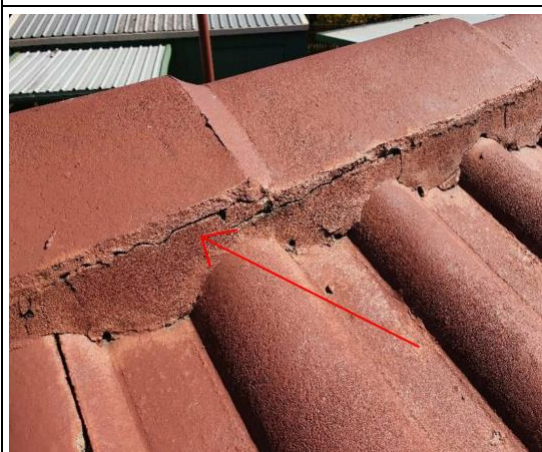
Generally the roof tiles are in a good and sound condition. There are several areas that have hairline cracking to the mortar joints on the ridge capping. These cracks are still watertight but would recommend to have these areas repaired in the future to maintain the integrity of the roof.

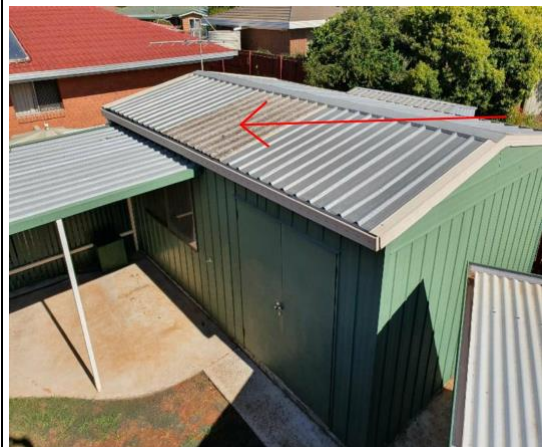
The external of the shed is in a good condition. The Alsynite roof sheeting is starting to show signs of aging. Eventually these alsynite sheets will need to be replaced.

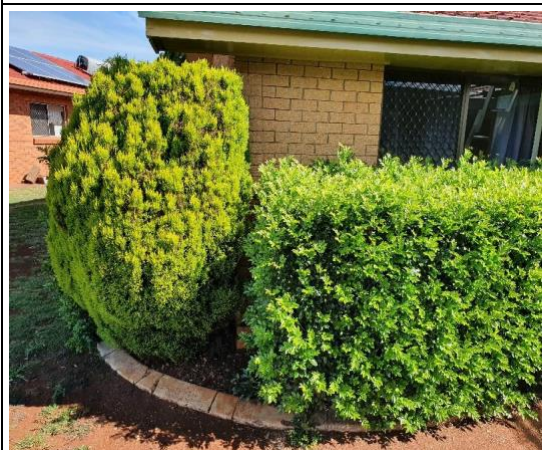
TREES-

There are trees and shrubs around the house. It would be highly recommended to remove the trees or shrubs away from the building.

Their root system can cause movement to the footing system. This can cause cracking to the plasterboard and brick work within the house.

Having plants and trees near the house can also attract Termites into the building and obstruct visual inspection of the external walls.

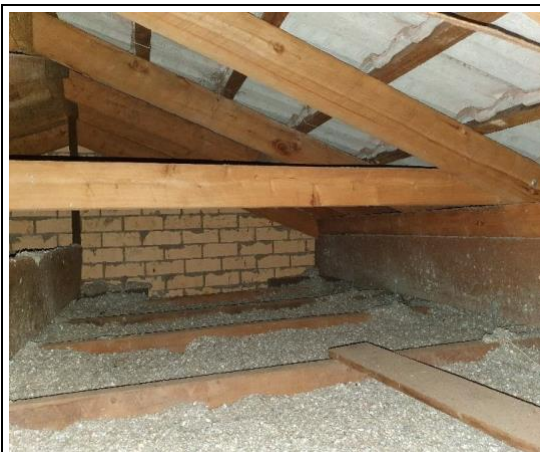
ROOF CAVITY CYPRESS-

The roof cavity appears to be in a **SOUND AND GOOD** condition.

Periodically inspect the ceiling cavity for any possible water leaks and maintenance repair work that maybe required over a period of time.

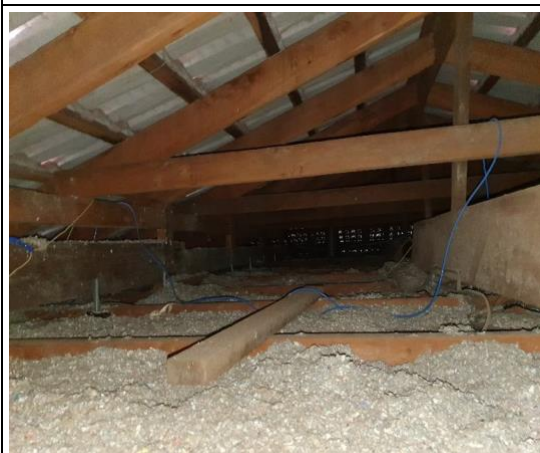
The roof framing appears to be in a good condition and structurally sound for the age of the building. There were no significant structural issues noticed at the time of the inspection.

This type of construction is typical for the age of the building.

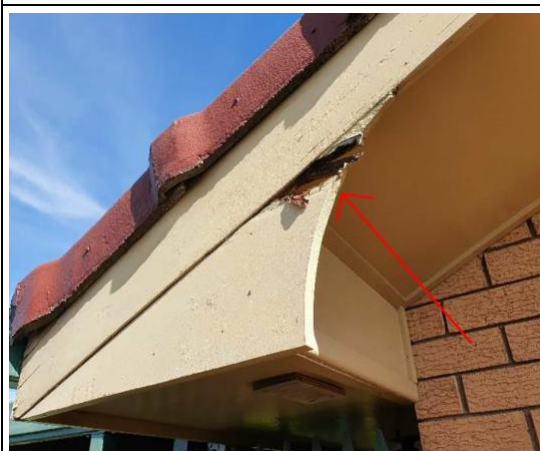
DRY ROT-

There were several minor areas that have dry rot on timber mouldings and Facia boards to the outside of the house. This is caused by moisture seeping into the timber over a long period of time and is most likely caused from poor painting standards.

Monitor these areas and repair as necessary.

This can normally be fixed by a Carpenter and a Painter.

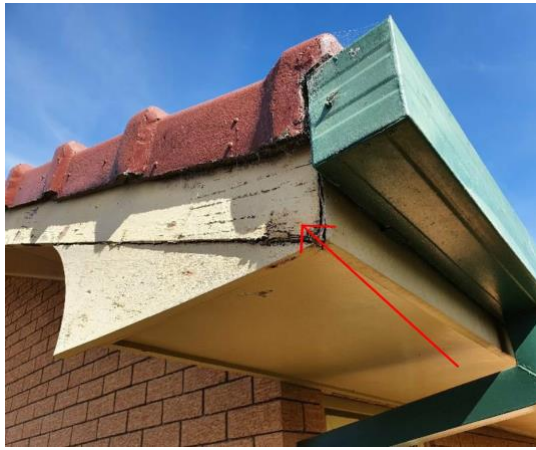
DRY ROT-

There were several minor areas that have dry rot on timber mouldings and Facia boards to the outside of the house. This is caused by moisture seeping into the timber over a long period of time and is most likely caused from poor painting standards.

Monitor these areas and repair as necessary.

This can normally be fixed by a Carpenter and a Painter.

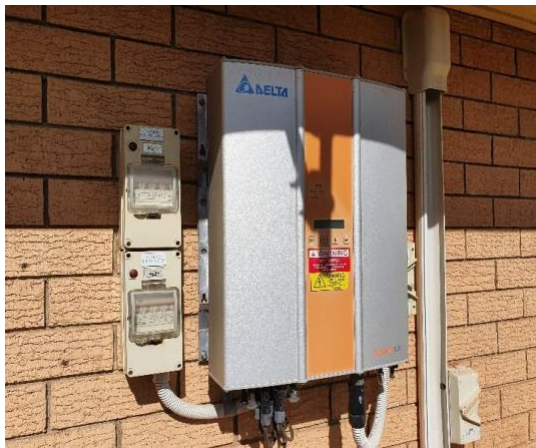
The inverter for the solar panels was working at the time of the inspection. The unit is currently producing electricity back into the grid. There does not appear to be any issues with this unit.

It would be suggested to confirm with a solar panel service agent.

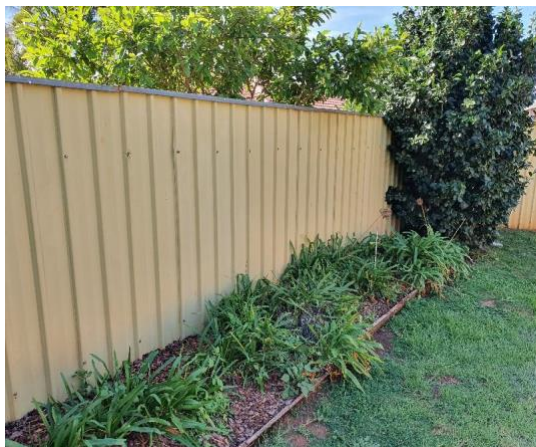
The colorbond fences appear to be structurally sound and in a good condition.

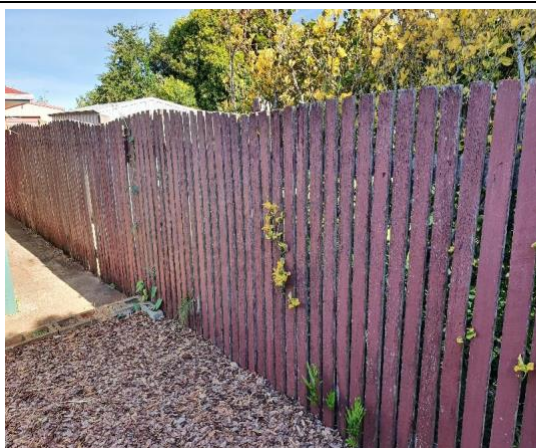
The timber fence on the left-hand side of the property is showing signs of decay and aging.

This fence is going to require repair work or possibly replacing in the future.

Seek further advice from a fencing contractor.

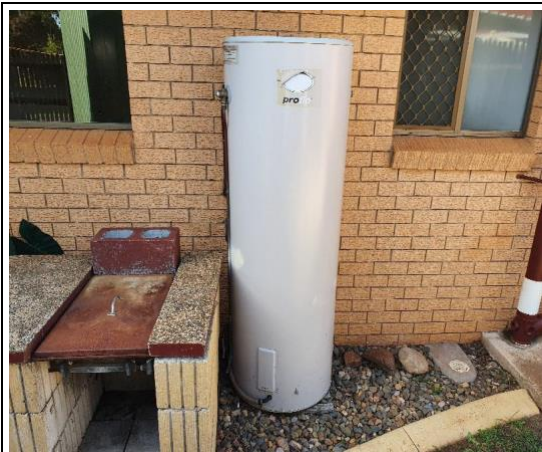
HOT WATER SYSTEM-

The Hot water system appears to be in a GOOD condition for the age of the unit.

Note- The average age of a Hot water system if maintained is 15 to 18 years. After this time frame, the unit may need to be replaced. This is to be done by a Plumber.

Confirm the working condition of the unit with a Plumber or service agent.

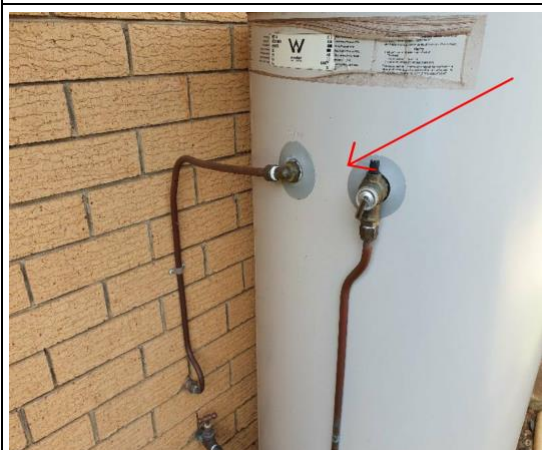
TEMPERING VALVE.

This hot water system does not have a tempering valve installed. A tempering valve is designed so the water only reaches 55 degrees. This is so people cannot be scolded by hot water.

This would be a council requirement to have a tempering valve installed when the unit was installed. It would be recommended to have a Tempering Valve installed.

Seek further advice from a Plumber.

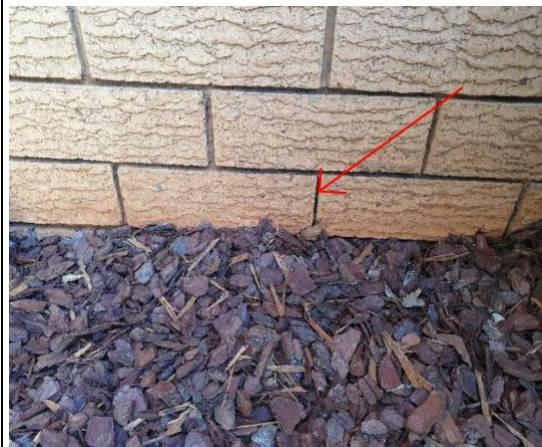
WEEP HOLES-

The weep holes to the brickwork are partially covered over by the concrete or garden bed. This can allow Termites to gain access into the building without being detected through the weep holes.

Remove the garden bed away from the weep holes so there is a 75mm clearance.

See Pest Report for further details if there is concrete breaching the weep holes.

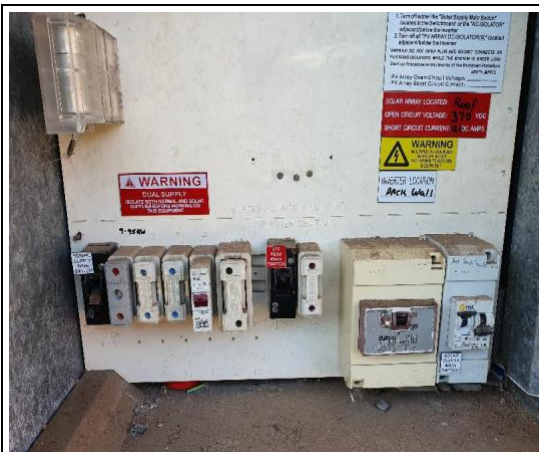
CERAMIC FUSES-

The meter box does have an RCD safety switch. The safety switch was not tested at the time of the inspection. Basic testing was carried at the time of the of the inspection but it is recommended to have an Electrician inspect and report on the electrical wiring, power points, lights and appliances to the house to confirm .

The meter box still has old style ceramic fuses installed that were used in the era when the house was originally built. These fuses are still compliant, but it would be SUGGESTED to update the fuses. These ceramic fuses can be exchanged with circuit braker fuses that do not use a fuse wire that are easily reset should the circuit braker trip and turn off.

This should easily be able to be installed by an Electrician. It is recommended to test the RCD safety switch every month.

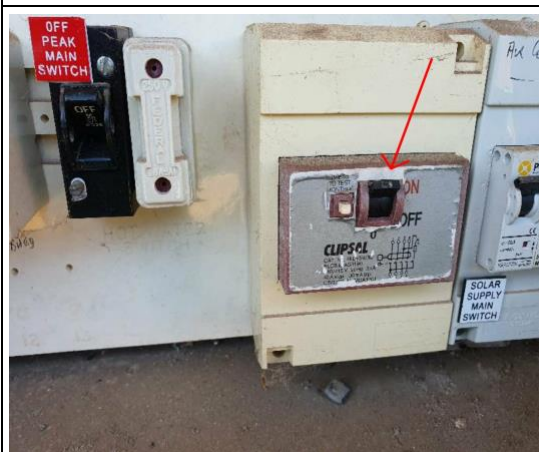
The safety switch in the metre box was working at the time of the inspection and is compliant. This switch is showing signs of aging. It would be suggested to have this safety switch replaced in the near future to maintain the integrity and safety reliability.

Seek further advice from an electrician.

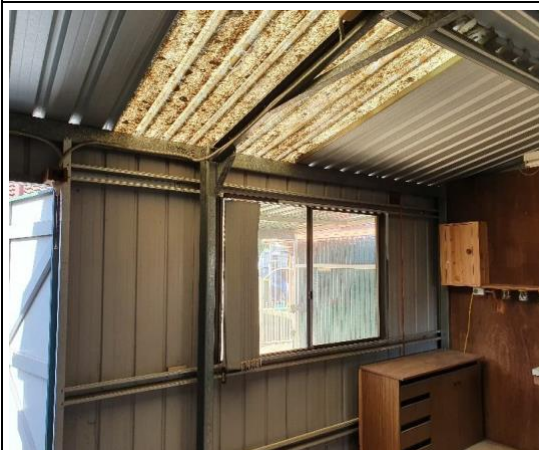
SHED.

The shed appears to be structurally sound and in a good condition from what could be visually seen.

It would be recommended to have a structural Engineer confirm the design of the shed that the metal framing are the correct sizes.

Confirm with council if the shed has building approvals in place.

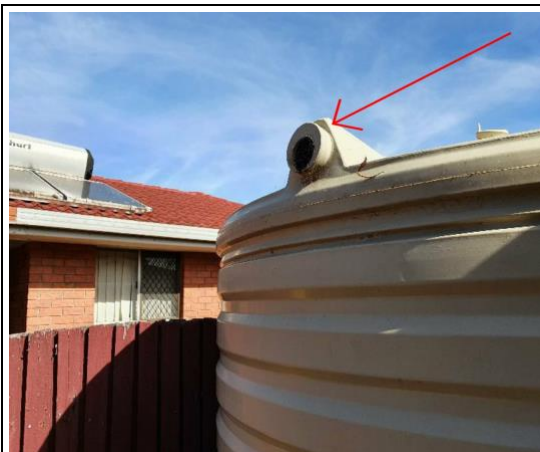
The overflow pipe on the rainwater tank has not been installed. It would be recommended to have a Plumber install this downpipe on the tank and the water diverted away from the building.

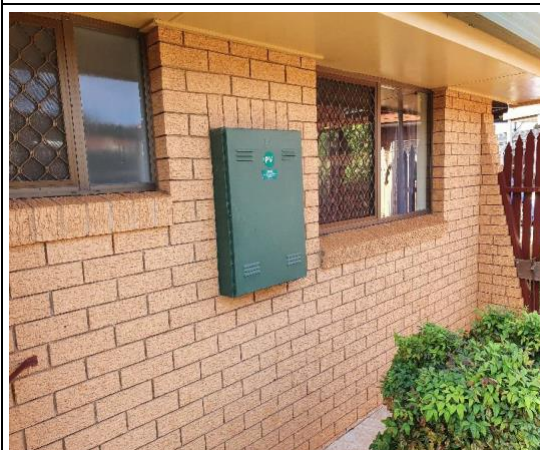
BRICK WORK-

The brick work appears to be in a GOOD CONDITION. There was no cracking noticed or sighted at the time of the inspection. There is a possibility that there will be "Hairline cracking" to some areas of the brick work that may not have been noticed. Depending on the amount of hairline cracks, this is a typical occurrence. Monitor the brick work and seek advice from an Engineer should any cracking starts to develop in the future.

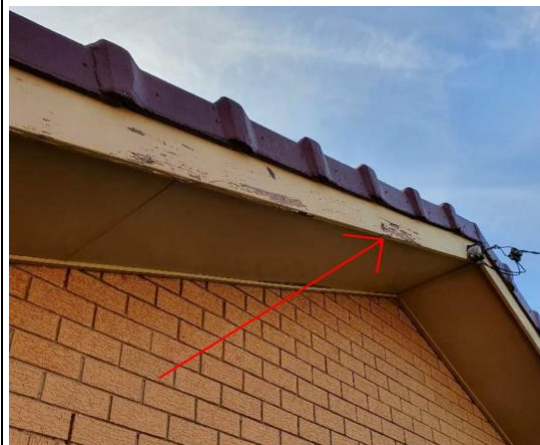
The barge boards at the front of the house are going to require painting to maintain the appearance and prevent dry rot occurring to the timber over time.

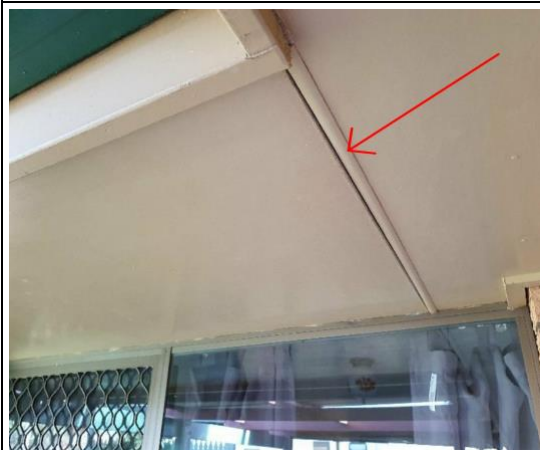
The fibro on the soffit at the front of the house is coming out of the joiner strip. This will need to be repaired by a carpenter.

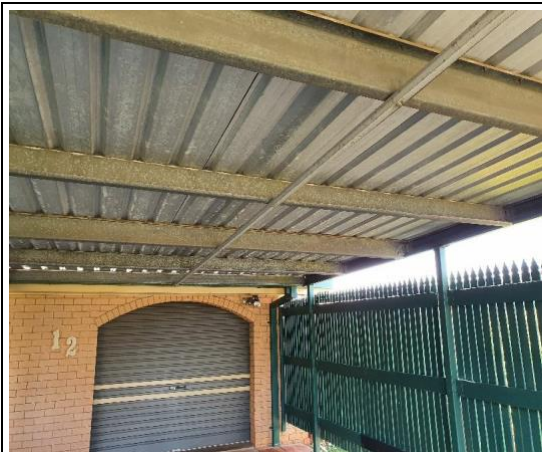
The carport at the front of the building appears to be structurally sound and in a good condition. There is some minor wear and tear to the paintwork that is to be expected for the age of the building.

It will need to be confirmed if this area has acquired council approval and building permits before going unconditional as this area may not meet council requirements with the Building code. Seek advice from your Solicitor.

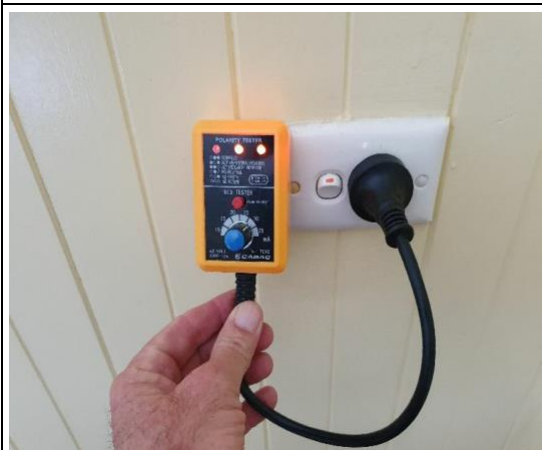
Several of the PowerPoints were tested at the time of the inspection. There does not appear to be any issues or faults with the Power Points.

This will need to be confirmed with an electrician.

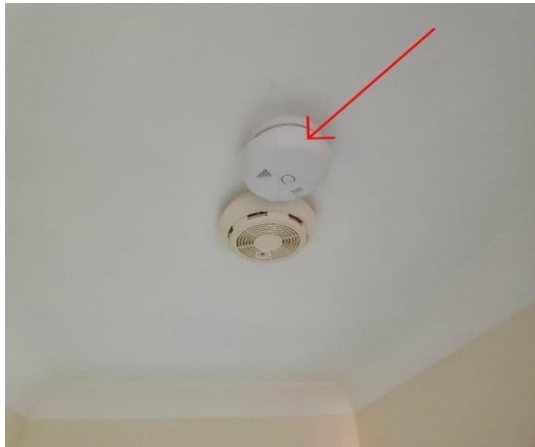
SMOKE ALARM-

The smoke alarm is still compliant but would suggest to have replaced with a new Photoelectric smoke alarm as it is almost out of date.

New smoke alarm rules started January 2017. Smoke alarms must be replaced once they are 10 years old with a Photo Electric type smoke alarm. Ensure that the Bedrooms do have a smoke alarm outside in the Hallway protecting the room from possible fires from the Kitchen area.

Seek further advice from an Electrician or visit www.qfes.qld.gov.au for more details.

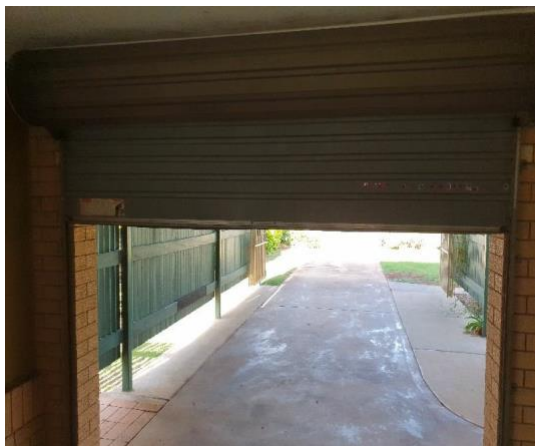
The roller door was working at the time of the inspection. The door is tending to close by itself when not fully opened. It would be recommended to have this door adjusted.

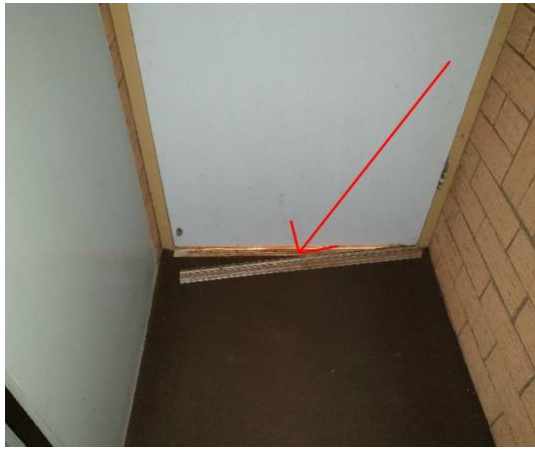
The weather seal to the back door has fallen off and will need to be reinstalled.

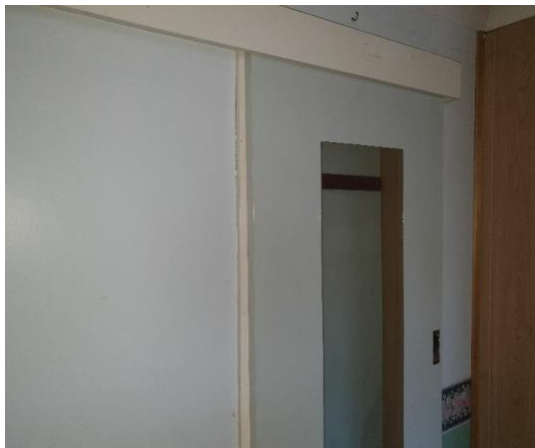
The sliding door in the garage has come off the track and would not open. Seek further advice from a carpenter.

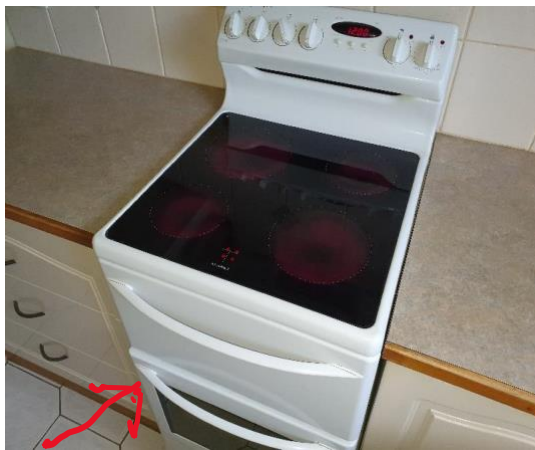
The cooktop on the stove was working at the time of the inspection.
The door on the oven would not close fully and will need to be adjusted.

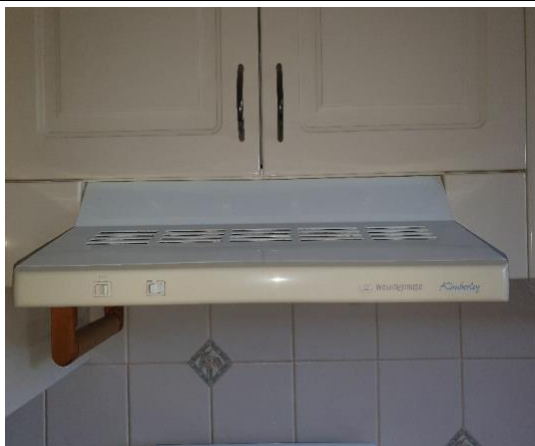
The range hood above the stove was not working at the time of the inspection. This rangehood will most likely need to be replaced.

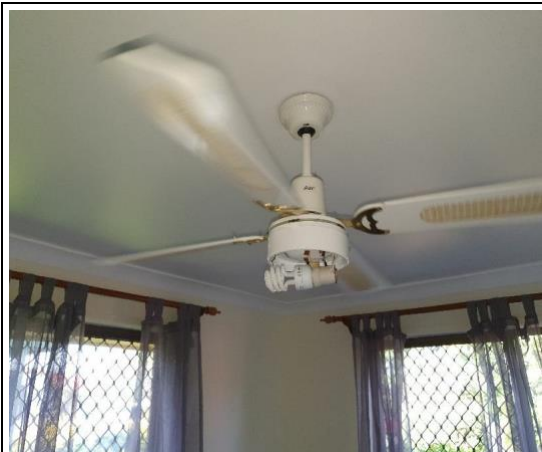
The light shade to the ceiling fan in the main bedroom is not installed.

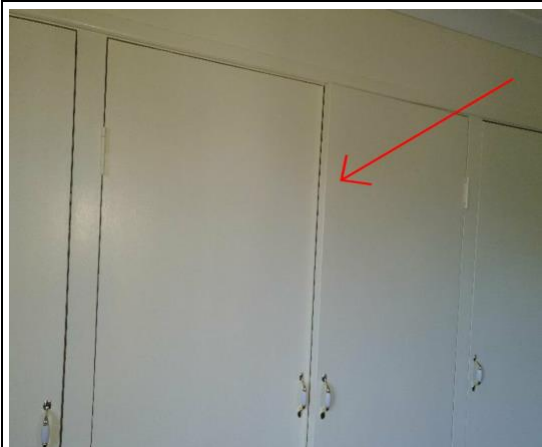
The cupboard doors in the main bedroom are out of alignment and will need to be adjusted.

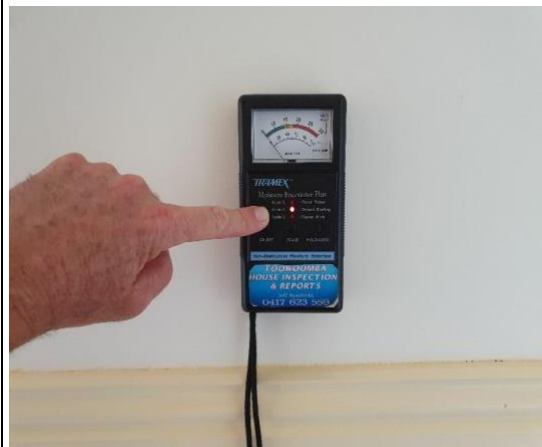
There was no moisture or water leaks located behind the shower when tested with a moisture metre. There was no signs of swelling to the moldings on the outside of the shower at the time of the inspection.

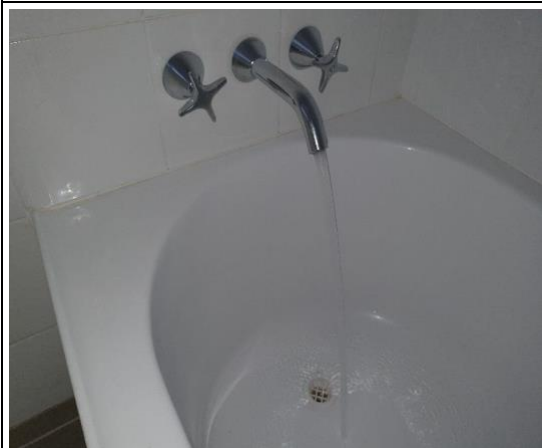
The water was flowing away when tested. There does not appear to be any blockages to the drainpipes.

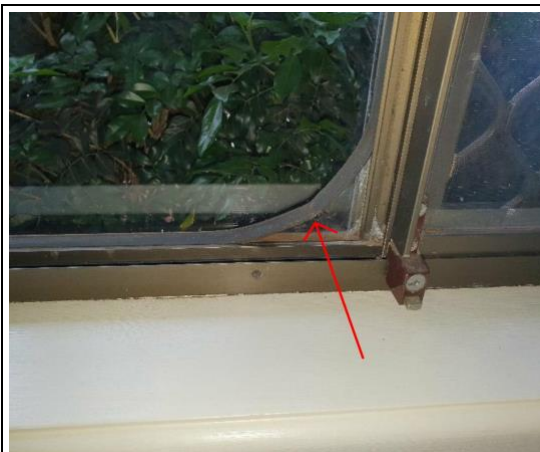
The rubber seals to several of the windows is coming away from the aluminium frame.

It would be recommended to have these seals replaced to maintain the windows.

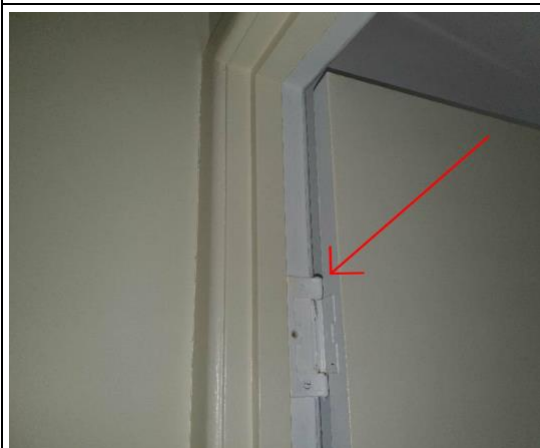
TOILET HINGE.

The hinges on the toilet door are the incorrect type of hinge to be used on a toilet door. These hinges are to be a "lift off hinges". This is so the door can be removed in case of an emergency.

Seek further advice from a carpenter to have installed.

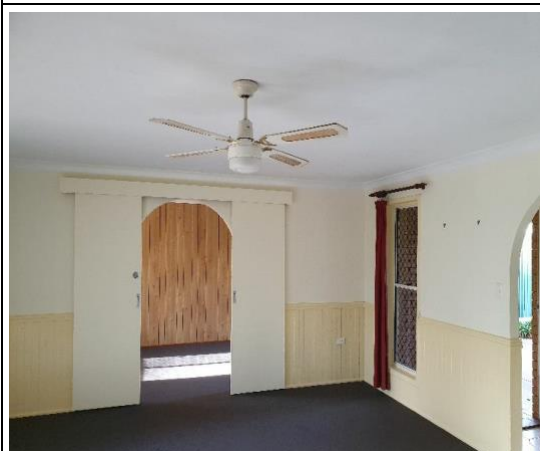
WEAR AND TEAR-

There are normal wear and tear marks throughout the building that is to be expected.

This can include minor dents to the walls, hairline cracks to the plasterboard walls and ceilings, dirt marks, ect throughout the building on the internal walls and ceiling.

This is FAIR for a house of this age that has been lived in. Not all defects have been noted in the report due to being minor defects.

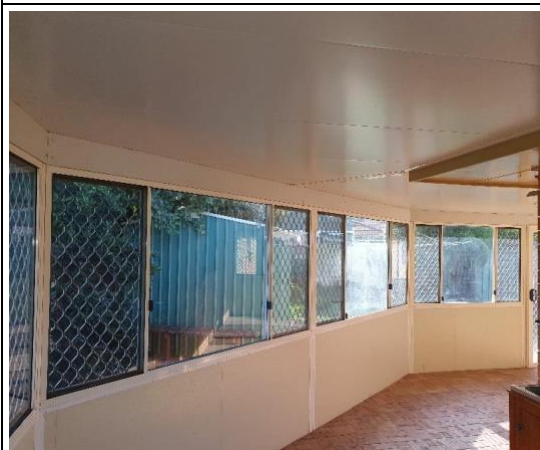
COUNCIL PERMITS-

Closed in Pergola area.
